**Flood Control Project Maintenance
Levee Inspections**
LMA District Cover Sheet
Spring 2019 Levee Inspection Results

Reclamation District No. 0150 Merrit Island

Spring 2019 Levee Inspection Results

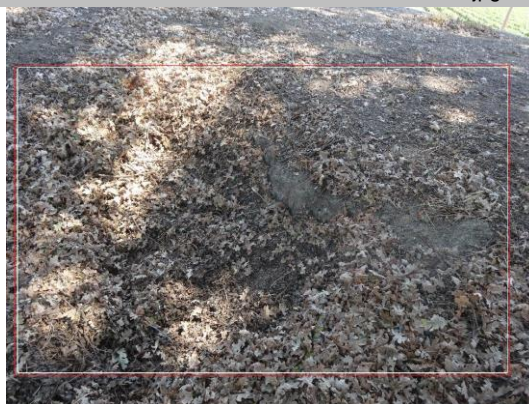
Photo 3 of 3 : UCIP_SP_2019_50202_35017.jpg

WS view: soil erosion (depression) on levee slope.

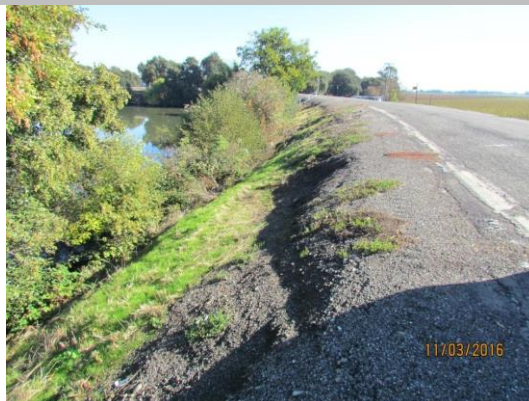
Photo 1 of 1 : SP_2019_RD0150_17_116_20190307_00104.jpg

View of slope instability on the waterside of the levee. Fall 2016

LM Start	3.79	Rating **	M	Issue No.	116
LM End	3.79	Issue Type +	Ma	Location *	WS
Category	Earthen Levee			GPS Latitude/Longitude	
				Start	End
Item	Slope Stability			38.367535 °	38.367535 °
				-121.552815 °	-121.552815 °
DWR ID	DWR_RD0150_03_f_2013_116				
Comment Code					
S1 : Repair slope instability.					
Inspector Comment

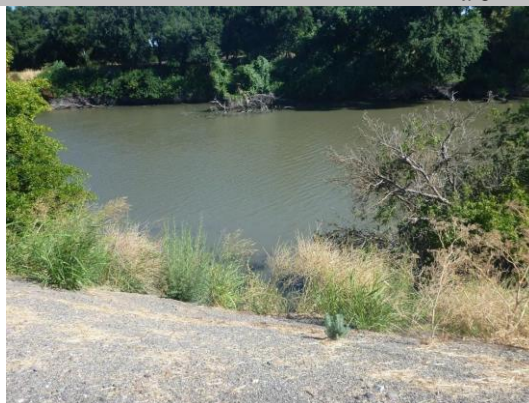
Photo 1 of 3 : LEVAL_SP_2019_304_2072.jpg

Comment Code					
Inspector Comment					
Levee Evaluation Comments					
Description:Between 11 and 19 January 2017, waterside instability and erosion were observed on the east (left) bank of Elk Slough. The site is approximately 88 feet long, 7 feet below the levee crest, and includes a fallen tree and exposed root ball in the levee slope. See attached pages for photos.					
Site ID No:304					
Site Designation:LMA-130					
Repair Type: Erosion					
Rating:Serious					
Field Date:7/18/2017					
Notes: Crown is a paved road. Near vertical on lower 1/2 of slope including a fallen tree with exposed root ball. Serious because sloughing cuts into already over-steepened prism significantly and visible longitudinal cracking near crown.

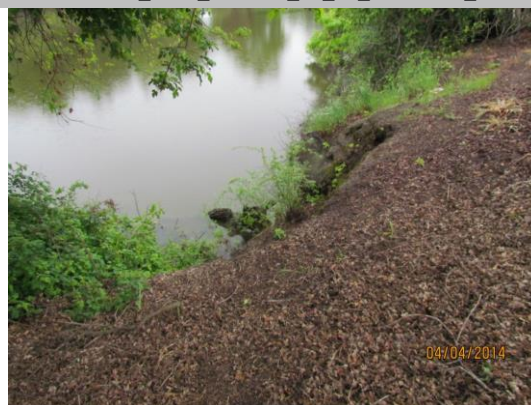
Photo 1 of 1 : SP_2019_RD0150_17_80_20190307_00065.jpg

LM Start	4.49	Rating **	A/W	Issue No.	80
LM End	4.49	Issue Type +	Ma	Location *	WS
Category	Earthen Levee			GPS Latitude/Longitude	
				Start	End
Item	Erosion / Bank Caving			38.374355 °	38.374355 °
				-121.547436 °	-121.547436 °
DWR ID	DWR_RD0150_03_s_2014_80				
Comment Code					
E1 : Note and monitor erosion site.					
Inspector Comment

View of an erosion site on the waterside toe of the levee looking upstream. Spring 2014

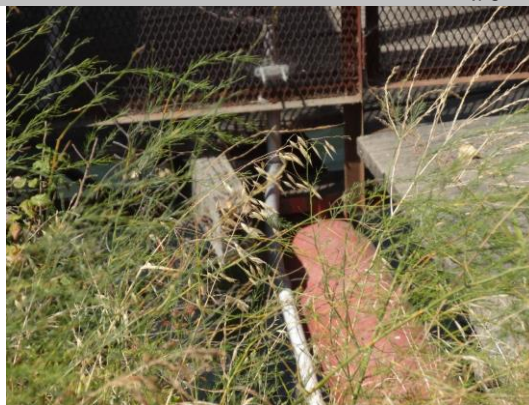
LM Start	4.63	Rating **	M	Issue No.	957	
LM End	4.63	Issue Type +	En	Location *		
Category	Supplemental			GPS Latitude/Longitude		
				Start	End	
Item	DWR UCIP Field Study			38.374934 °	38.374934 °	
				-121.545029 °	-121.545029 °	
DWR ID	22444					
Comment Code						
Inspector Comment						
FS_ID:19281 DS_ID:22444 EP_NO: N/A Repair Type: Non-Urgent Crossing Status: Found UCIP Comments: - service pole on LS. 1" conduit on WS.- levee toe cut out on landside.- walkway and gate. FIELD_STRUCT_DESC: 10-inch steel irrigation discharge pipe through the levee, invert elevation 3.8 feet below the crown. Pump on pilings in the stream. Concrete standpipe at the landside (LS) toe. (P. Cook). [Additional Reference(s): DWR Levee Log, 2005. USACE Sacramento O&M Manual 112, March 1957, (HLM 4.71)]. FS Date: 8/20/2013

WS view: vertical pump on deck.

WS view: 1-inch GI conduit (left) and steel pipe (right)

WS view: safety valve on steel pipe.

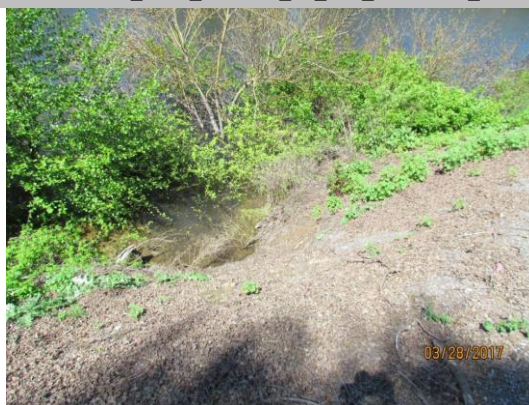
Photo 1 of 1 : SP_2019_RD0150_17_101_20190307_00088.jpg

View of an erosion on the waterside toe of the levee. Spring 2017

LM Start	4.79	Rating **	M	Issue No.	101
LM End	4.79	Issue Type +	Ma	Location *	WS
Category	Earthen Levee			GPS Latitude/Longitude	
				Start	End
Item	Erosion / Bank Caving			38.376562 °	38.376562 °
				-121.543016 °	-121.543016 °
DWR ID	DWR_RD0150_03_s_2017_101				
Comment Code					
E2 : Schedule repair of erosion site prior to the next inspection.					
Inspector Comment

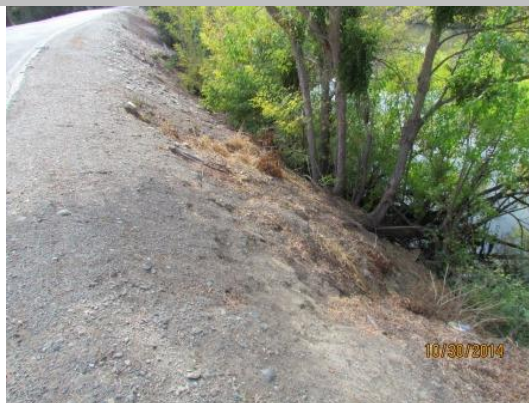
Photo 1 of 1 : SP_2019_RD0150_17_81_20190307_00066.jpg

View of erosion on the waterside of the levee looking downstream. Fall 2014

LM Start	5.05	Rating **	M	Issue No.	81
LM End	5.05	Issue Type +	Ma	Location *	WS
Category	Earthen Levee			GPS Latitude/Longitude	
				Start	End
Item	Erosion / Bank Caving			38.379608 °	38.379608 °
				-121.540082 °	-121.540082 °
DWR ID	DWR_RD0150_03_f_2014_81				
Comment Code					
E2 : Schedule repair of erosion site prior to the next inspection.					
Inspector Comment

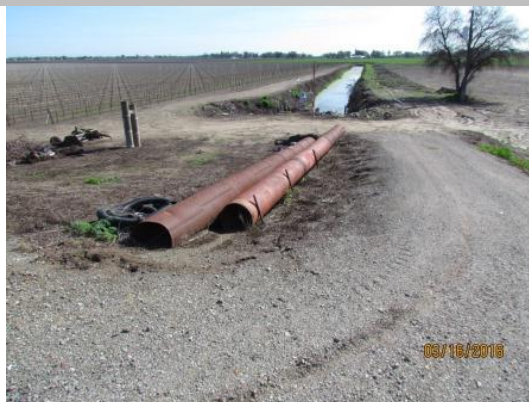
Photo 1 of 1 : SP_2019_RD0150_17_95_20190307_00081.jpg

LM Start	5.05	Rating **	M	Issue No.	95
LM End	5.05	Issue Type +	En	Location *	LS
Category	Earthen Levee			GPS Latitude/Longitude	
				Start	End
Item	Encroachments			38.379617 °	38.379617 °
				-121.540058 °	-121.540058 °
DWR ID	DWR_RD0150_03_s_2016_95				
Comment Code					
PI : Pipe					
Inspector Comment					
Abandoned pipe was found on the landside slope of the levee.

View of an abandoned pipe on the landside slope of the levee. Spring 2016

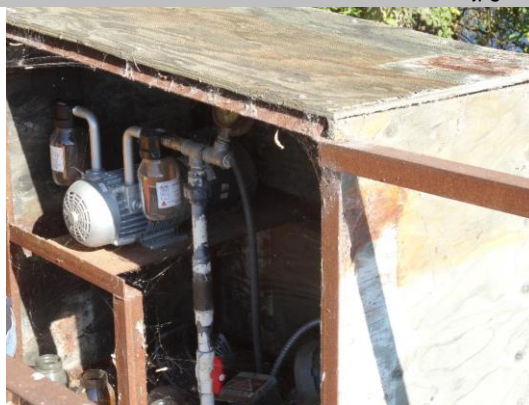
Photo 2 of 3 : UCIP_SP_2019_49386_63901.jpg

WS view: a smaller pump on steel deck. It was working during the survey.

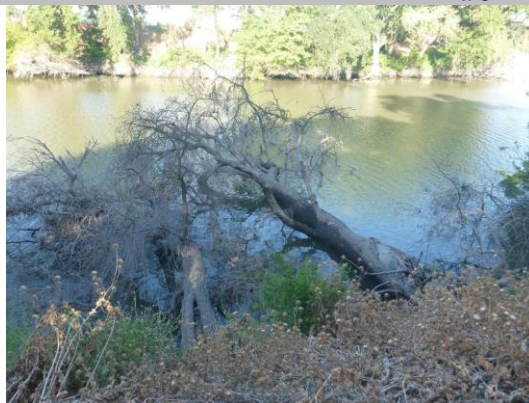
Photo 1 of 3 : LEVAL_SP_2019_309_2036.jpg

LM Start	5.15	Rating **	A/W	Issue No.	111
LM End	5.15	Issue Type +	Ma	Location *	WS
Category	Supplemental			GPS Latitude/Longitude	
				Start	End
Item	2017 Storm Damage			38.380906 °	38.380928 °
				-121.540344 °	-121.540364 °
DWR ID	DWR_RD0150_03_f_2017_111

Comment Code					
Inspector Comment					
Levee Evaluation Comments					
Description:On 19 January 2017, two large trees were observed to have fallen into the water exposing the root ball on the waterside levee slope on the east (left) bank of Elk Slough. The site is approximately 10 feet long. See attached pages for photos.					
Site ID No:309					
Site Designation:LMA-135					
Repair Type: Erosion					
Rating:Area of Concern					
Field Date:7/18/2017					
Notes: 2 oak trees fell over at the WS toe and took root balls out of the lower slope about 5 ft deep just above the water line. Area of concern because damage is only on the lower slope near the water line. Spring 2019 DWR Inspection: Erosion was not visible due to high water.

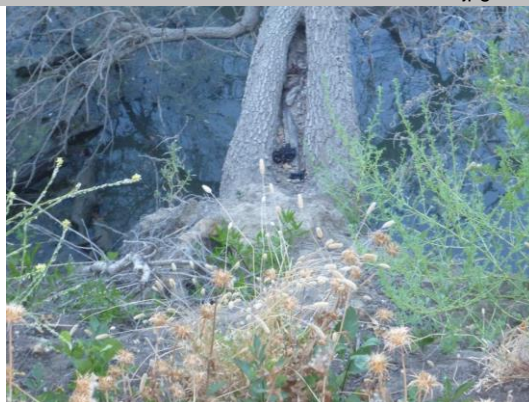
Photo 2 of 3 : LEVAL_SP_2019_309_2038.jpg

LM Start	5.15	Rating **	A/W	Issue No.	111 (cont)
LM End	5.15	Issue Type +	Ma	Location *	WS

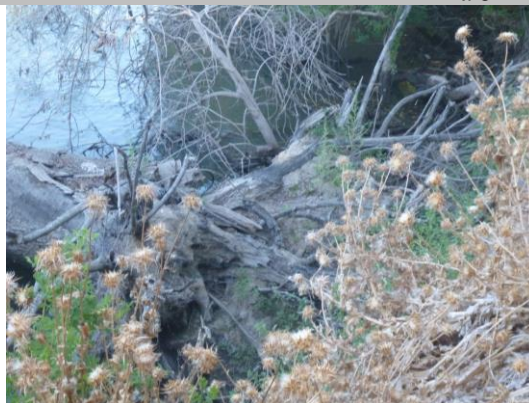
Photo 3 of 3 : LEVAL_SP_2019_309_2039.jpg

LM Start	5.15	Rating **	A/W	Issue No.	111 (cont)
LM End	5.15	Issue Type +	Ma	Location *	WS
Category	Supplemental			GPS Latitude/Longitude	
				Start	End
Item	2017 Storm Damage			38.380906 °	38.380928 °
				-121.540344 °	-121.540364 °
DWR ID	DWR_RD0150_03_f_2017_111

Comment Code					
Inspector Comment					
Levee Evaluation Comments					
Description:On 19 January 2017, two large trees were observed to have fallen into the water exposing the root ball on the waterside levee slope on the east (left) bank of Elk Slough. The site is approximately 10 feet long. See attached pages for photos.					
Site ID No:309					
Site Designation:LMA-135					
Repair Type: Erosion					
Rating:Area of Concern					
Field Date:7/18/2017					
Notes: 2 oak trees fell over at the WS toe and took root balls out of the lower slope about 5 ft deep just above the water line. Area of concern because damage is only on the lower slope near the water line. Spring 2019 DWR Inspection: Erosion was not visible due to high water.

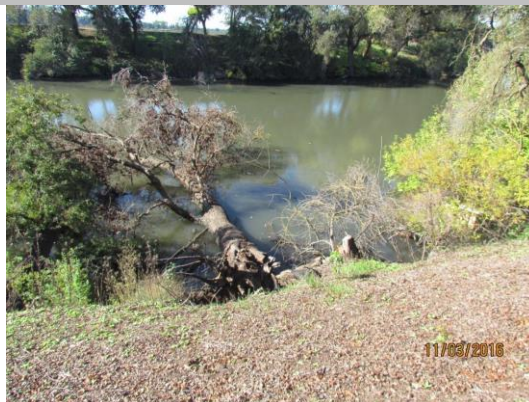
Photo 1 of 1 : SP_2019_RD0150_17_72_20190307_00058.jpg

LM Start	5.15	Rating **	A/W	Issue No.	72
LM End	5.15	Issue Type +	Ma	Location *	WS
Category	Earthen Levee			GPS Latitude/Longitude	
				Start	End
Item	Encroachments			38.380940 °	38.380940 °
				-121.540384 °	-121.540384 °
DWR ID	DWR_RD0150_03_f_2016_72				
Comment Code					
TR : Tree or limb					
Inspector Comment					
Tree stump and broken tree were found on the waterside toe but were not visible during Spring inspection due to high water.

View of tree stump and broken tree on the waterside toe of the levee.
Fall 2016

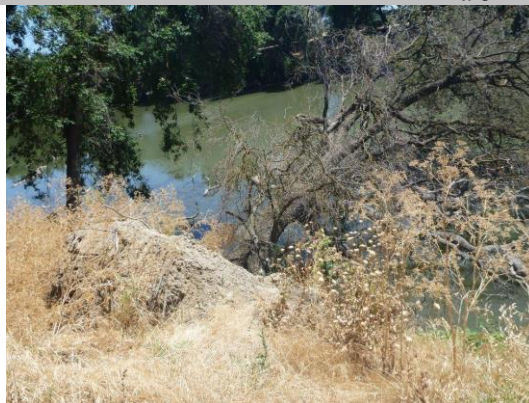
Photo 3 of 3 : LEVAL_SP_2019_310_2191.jpg

LM Start	5.40	Rating **	A/W	Issue No.	114 (cont)
LM End	5.41	Issue Type +	Ma	Location *	WS
Category	Supplemental			GPS Latitude/Longitude	
				Start	End
Item	2017 Storm Damage			38.382169 °	38.382206 °
				-121.544597 °	-121.544731 °
DWR ID	DWR_RD0150_03_f_2017_114

Comment Code					
Inspector Comment					
Levee Evaluation Comments					
Description:Cracking and erosion were observed on the waterside levee slope on the east (left) bank of Elk Slough. The site is approximately 40 feet long. See attached pages for photos.					
Site ID No:310					
Site Designation:LMA-136					
Repair Type: Erosion					
Rating:Serious					
Field Date:7/17/2017					
Notes: Large oak tree fell over here and took a root ball with it. At least 15 ft wide by 5ft deep soil missing, 5 ft from crown. Longitudinal cracks for 40 ft along crown hinge. Serious because prism is impacted and cracking is visible beyond the damaged area.

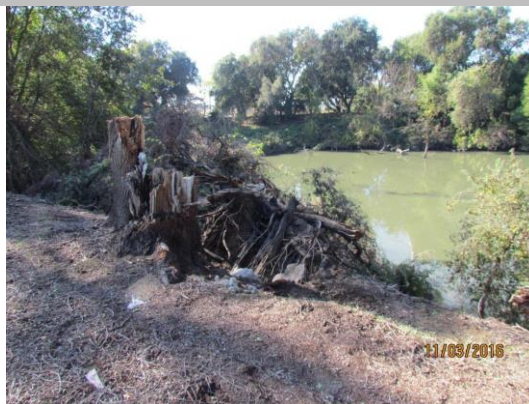
Photo 1 of 1 : SP_2019_RD0150_17_74_20190307_00062.jpg

LM Start	5.49	Rating **	N	Issue No.	74
LM End	5.49	Issue Type +	Ma	Location *	WS
Category	Earthen Levee			GPS Latitude/Longitude	
				Start	End
Item	Trim / Thin Trees			38.383051 °	38.383051 °
				-121.545735 °	-121.545735 °
DWR ID	DWR_RD0150_03_f_2016_74				
Comment Code					
T5 : Tree stumps.					
Inspector Comment					
Tree stump and broken tree on the waterside shoulder of the levee need to be removed.

View of tree trunks on the waterside shoulder of the levee. Fall 2016

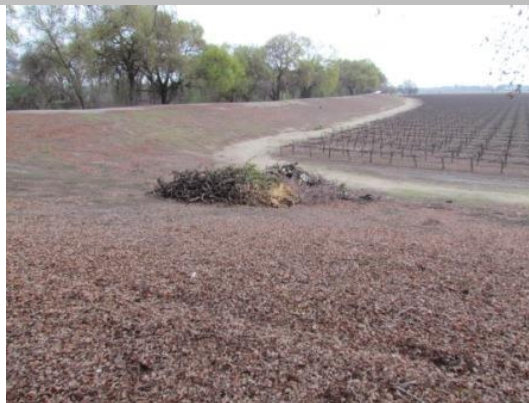
Photo 1 of 2 : SP_2019_RD0150_17_12_20190307_00002.jpg

LM Start	5.50	Rating **	M	Issue No.	12
LM End	5.50	Issue Type +	En	Location *	LS
Category	Earthen Levee			GPS Latitude/Longitude	
				Start	End
Item	Encroachments			38.383099 °	38.383099 °
				-121.545744 °	-121.545744 °
DWR ID	DWR_RD0150_03_s_2012_12				
Comment Code					
PR : Prunings					
Inspector Comment

Prunings were found on the landside toe of the levee looking upstream.

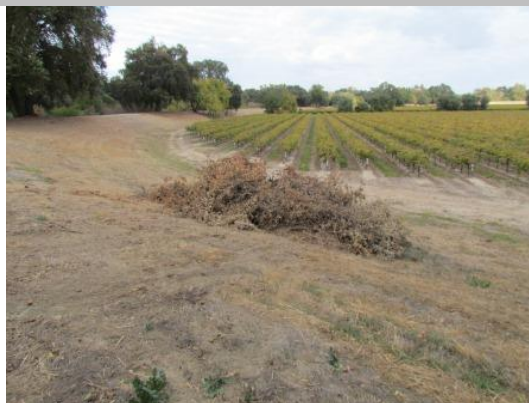
Photo 2 of 2 : SP_2019_RD0150_17_12_20190307_00003.jpg

LM Start	5.50	Rating **	M	Issue No.	12 (cont)
LM End	5.50	Issue Type +	En	Location *	LS

View of pruning pile on the landside toe of the levee looking upstream during the fall 2013 inspection.

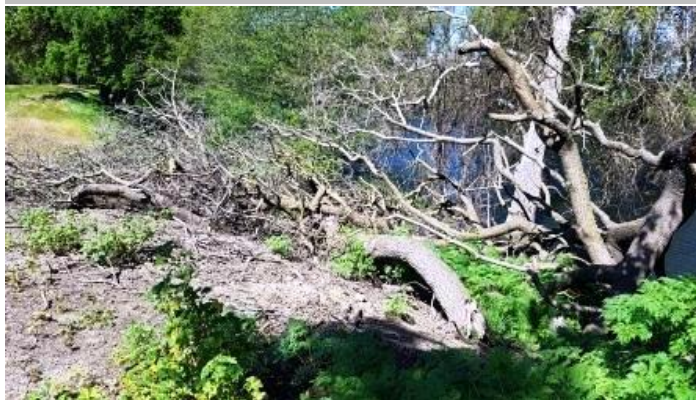
Photo 1 of 2 : SP_2019_RD0150_17_150_20190415_00174.jpg

LM Start	5.64	Rating **	M	Issue No.	150
LM End	5.64	Issue Type +	Ma	Location *	WS
Category	Earthen Levee			GPS Latitude/Longitude	
				Start	End
Item	Encroachments			38.383825 °	38.383825 °
				-121.543683 °	-121.543683 °
DWR ID	DWR_RD0150_03_s_2019_150				
Comment Code					
TR : Tree or limb					
Inspector Comment					
Remove tree debris from levee shoulder and slope.

View of tree debris on waterside slope. Spring 2019

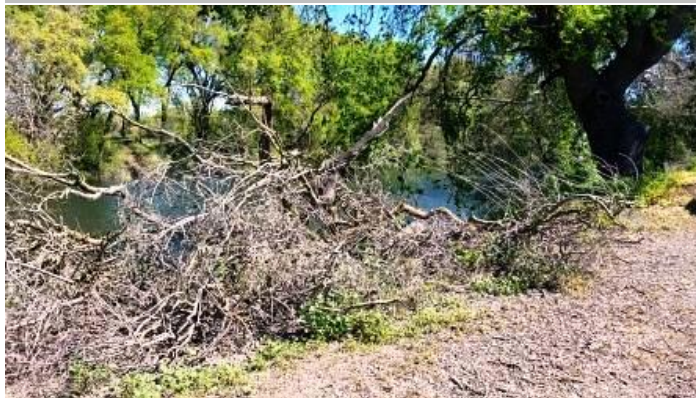
Photo 2 of 2 : SP_2019_RD0150_17_150_20190415_00175.jpg

LM Start	5.64	Rating **	M	Issue No.	150 (cont)	
LM End	5.64	Issue Type +	Ma	Location *	WS	
Category	Earthen Levee			GPS Latitude/Longitude		
				Start		End
Item	Encroachments			38.383825 °		38.383825 °
				-121.543683 °		-121.543683 °
DWR ID	DWR_RD0150_03_s_2019_150					
Comment Code						
TR : Tree or limb						
Inspector Comment						
Remove tree debris from levee shoulder and slope.

View of tree debris on waterside slope. Spring 2019

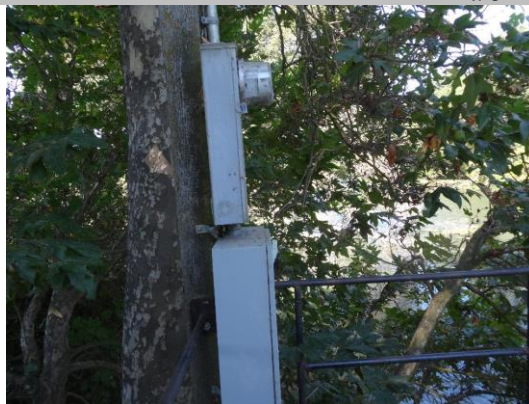
Photo 2 of 3 : UCIP_SP_2019_28265_51973.jpg

LM Start	5.70	Rating **	M	Issue No.	960 (cont)
LM End	5.70	Issue Type +	En	Location *

WS view: electric control box and power pole.

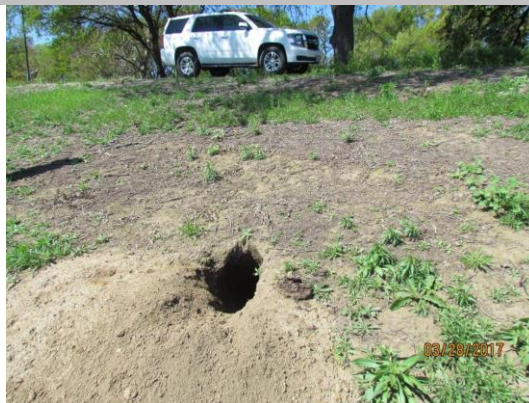
Photo 2 of 2 : SP_2019_RD0150_17_104_20190307_00090.jpg

LM Start	5.71	Rating **	U	Issue No.	104 (cont)	
LM End	5.71	Issue Type +	Ma	Location *	LS	
Category	Earthen Levee			GPS Latitude/Longitude		
				Start		End
Item	Animal Control			38.384026 °		38.384026 °
				-121.542455 °		-121.542455 °
DWR ID	DWR_RD0150_03_s_2017_104					
Comment Code						
A3 : No rodents visible, but rodent burrows visible; need to backfill and compact or grout burrows.						
Inspector Comment						
Animal hole appears to be inactive but should be backfilled.

View of a rodent hole on the landside toe of the levee. Spring 2017

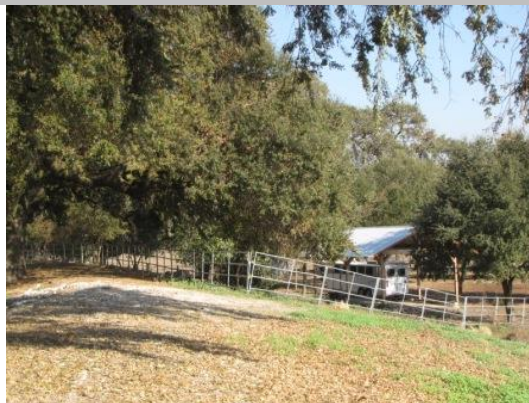
Photo 1 of 1 : SP_2019_RD0150_17_56_20190307_00043.jpg

LM Start	5.79	Rating **	M	Issue No.	56
LM End	5.83	Issue Type +	En	Location *	LS
Category	Earthen Levee			GPS Latitude/Longitude	
				Start	End
Item	Encroachments			38.384363 °	38.384796 °
				-121.541161 °	-121.540525 °
DWR ID	DWR_RD0150_03_s_2012_56				
Comment Code					
FE : Fence					
Inspector Comment

View of fence around a horse pen along the shoulder of the levee and the landward slope.

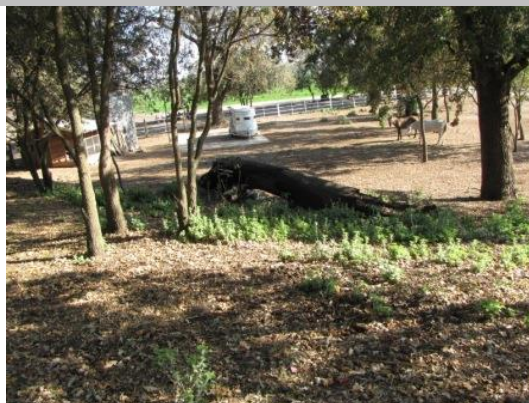
Photo 1 of 1 : SP_2019_RD0150_17_57_20190307_00044.jpg

LM Start	5.82	Rating **	M	Issue No.	57
LM End	5.82	Issue Type +	Ma	Location *	LS
Category	Earthen Levee			GPS Latitude/Longitude	
				Start	End
Item	Encroachments			38.384648 °	38.384648 °
				-121.540669 °	-121.540669 °
DWR ID	DWR_RD0150_03_s_2012_57				
Comment Code					
TR : Tree or limb					
Inspector Comment

View of a tree trunk lying on the landward slope blocking visibility.

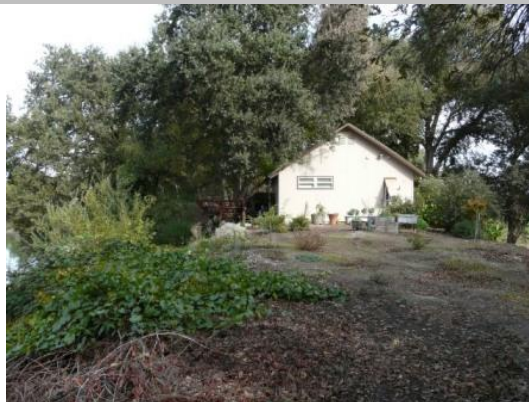
Photo 1 of 1 : SP_2019_RD0150_17_58_20190307_00045.jpg

LM Start	5.83	Rating **	U	Issue No.	58
LM End	5.83	Issue Type +	En	Location *	CR
Category	Earthen Levee			GPS Latitude/Longitude	
				Start	End
Item	Encroachments			38.384803 °	38.384803 °
				-121.540545 °	-121.540545 °
DWR ID	DWR_RD0150_03_s_2012_58				
Comment Code					
BU : Building					
Inspector Comment					
Permit 7517 approved house and graze cattle; 7517-A approved septic tank and 4-inch sewer line.

Building & associated landscaping on levee crown.

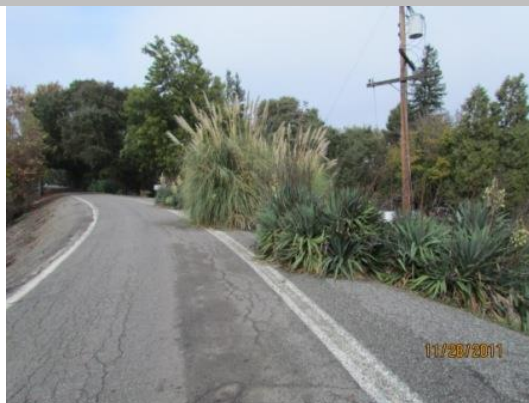
Photo 1 of 1 : SP_2019_RD0150_17_21_20190307_00006.jpg

LM Start	5.91	Rating **	U	Issue No.	21
LM End	5.98	Issue Type +	En	Location *	LS
Category	Earthen Levee			GPS Latitude/Longitude	
				Start	End
Item	Vegetation			38.385752 °	38.386703 °
				-121.539905 °	-121.540042 °
DWR ID	DWR_RD0150_03_s_2012_21				
Comment Code					
V6 : Landscaping					
Inspector Comment

Landscaping was found on the landside of the levee looking upstream.
Fall 2011

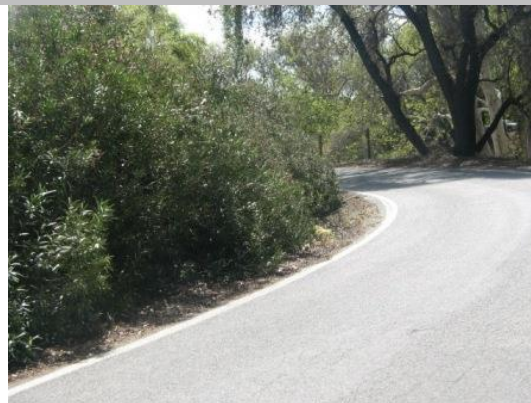
Photo 1 of 1 : SP_2019_RD0150_17_24_20190307_00007.jpg

LM Start	6.13	Rating **	U	Issue No.	24
LM End	6.20	Issue Type +	En	Location *	LS
Category	Earthen Levee			GPS Latitude/Longitude	
				Start	End
Item	Vegetation			38.388535 °	38.389391 °
				-121.541657 °	-121.541901 °
DWR ID	DWR_RD0150_03_s_2012_24				
Comment Code					
V6 : Landscaping					
Inspector Comment

Oleander on landward slope blocking view of levee.

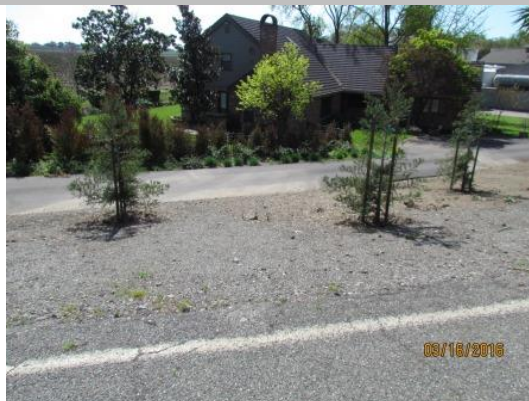
Photo 1 of 1 : SP_2019_RD0150_17_99_20190307_00087.jpg

LM Start	6.25	Rating **	M	Issue No.	99
LM End	6.25	Issue Type +	En	Location *	LS
Category	Earthen Levee			GPS Latitude/Longitude	
				Start	End
Item	Encroachments			38.389857 °	38.389857 °
				-121.541193 °	-121.541193 °
DWR ID	DWR_RD0150_03_s_2016_99				
Comment Code					
TR : Tree or limb					
Inspector Comment					
Landowner planted trees on the landside slope of the levee which are unpermitted and need to be removed.

View of planted trees on the landside slope of the levee. Spring 2016

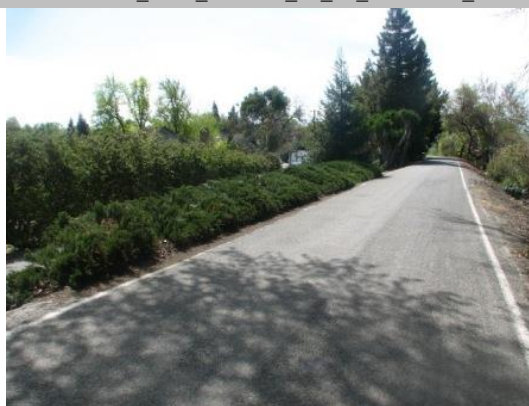
Photo 1 of 1 : SP_2019_RD0150_17_26_20190307_00008.jpg

LM Start	6.25	Rating **	U	Issue No.	26
LM End	6.29	Issue Type +	En	Location *	LS
Category	Earthen Levee			GPS Latitude/Longitude	
				Start	End
Item	Vegetation			38.389858 °	38.390115 °
				-121.541155 °	-121.540657 °
DWR ID	DWR_RD0150_03_s_2012_26				
Comment Code					
V6 : Landscaping					
Inspector Comment

Landscaping on landward slope.

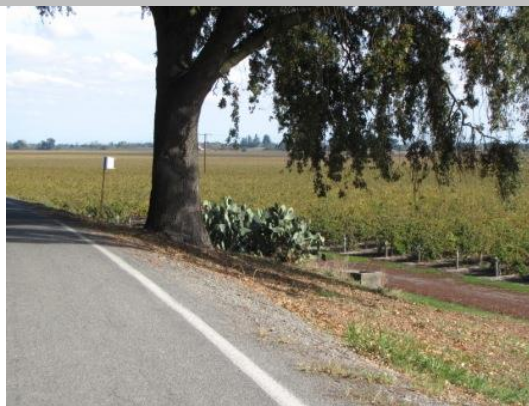
Photo 1 of 1 : SP_2019_RD0150_17_60_20190307_00047.jpg

LM Start	6.45	Rating **	M	Issue No.	60
LM End	6.45	Issue Type +	En	Location *	LS
Category	Earthen Levee			GPS Latitude/Longitude	
				Start	End
Item	Vegetation			38.391616 °	38.391616 °
				-121.538378 °	-121.538378 °
DWR ID	DWR_RD0150_03_s_2012_60				
Comment Code					
V6 : Landscaping					
Inspector Comment

View of landscaping along the landward slope.

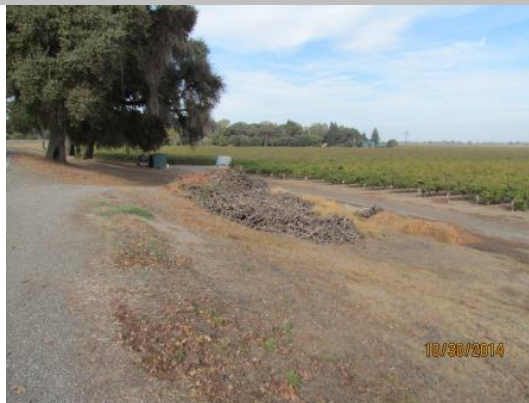
Photo 1 of 1 : SP_2019_RD0150_17_83_20190307_00068.jpg

LM Start	6.52	Rating **	M	Issue No.	83
LM End	6.52	Issue Type +	En	Location *	LS
Category	Earthen Levee			GPS Latitude/Longitude	
				Start	End
Item	Encroachments			38.392580 °	38.392580 °
				-121.538059 °	-121.538059 °
DWR ID	DWR_RD0150_03_f_2014_83				
Comment Code					
PR : Prunings					
Inspector Comment

Prunings were found on the landside toe of the levee looking upstream.
Fall 2014

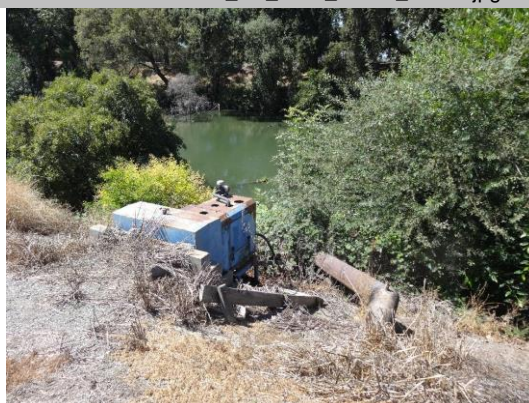
Photo 1 of 3 : UCIP_SP_2019_42692_35082.jpg

LM Start	6.63	Rating **	M	Issue No.	962
LM End	6.63	Issue Type +	En	Location *	
Category	Supplemental			GPS Latitude/Longitude	
				Start	End
Item	DWR UCIP Field Study			38.394182 °	38.394182 °
				-121.538609 °	-121.538609 °
DWR ID	22457				
Comment Code					
Inspector Comment					
FS_ID:42692 DS_ID:22457 EP_NO: 14650 Repair Type: Non-Urgent Crossing Status: Found UCIP Comments: Appears abandoned and if so should be done so properly. FIELD_STRUCT_DESC: 12-inch steel irrigation discharge pipe through the levee, 5 feet below the crown. Diesel powered slant pump on the waterside (WS). Concrete distribution box on the landside (LS) toe. (Plans to install a slant mounted pump on the WS of the levee with a 12-inch discharge pipe through the levee authorized under Permit No. 14650, 1987 - Webber Farms). [Additional Reference(s): DWR Levee Log, 2005]. FS Date: 8/23/2013

WS view: steel pipe (right) and diesel pump on levee slope.

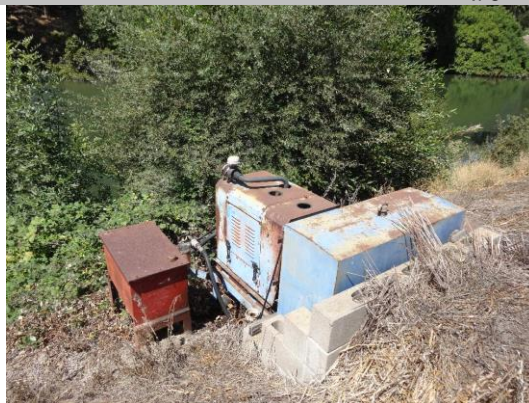
Photo 2 of 3 : UCIP_SP_2019_42692_35081.jpg

WS view: diesel pump on steepe levee slope.

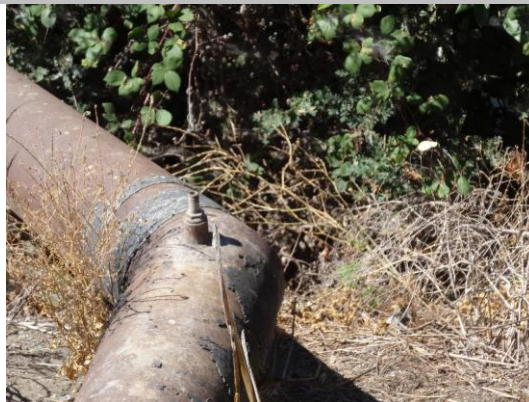
Photo 3 of 3 : UCIP_SP_2019_42692_35080.jpg

WS view: air vent on steel pipe.

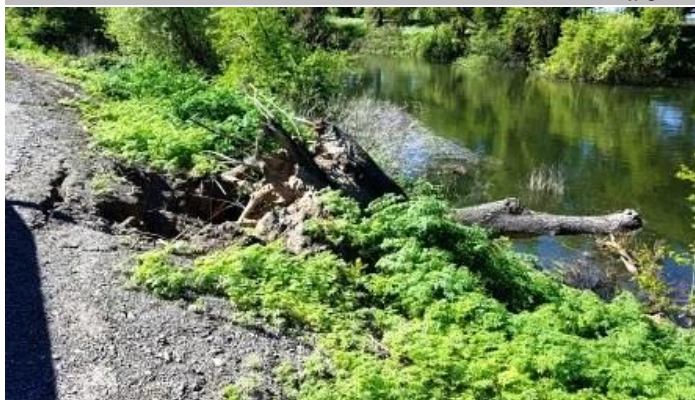
Photo 1 of 1 : SP_2019_RD0150_17_137_20190415_00171.jpg

LM Start	6.64	Rating **	M	Issue No.	137
LM End	6.64	Issue Type +	Ma	Location *	WS
Category	Earthen Levee			GPS Latitude/Longitude	
				Start	End
Item	Encroachments			38.394332 °	38.394332 °
				-121.538658 °	-121.538658 °
DWR ID	DWR_RD0150_03_s_2019_137				
Comment Code					
TR : Tree or limb					
Inspector Comment					
Remove fallen tree with exposed rootball.

View of fallen tree on waterside slope. Spring 2019

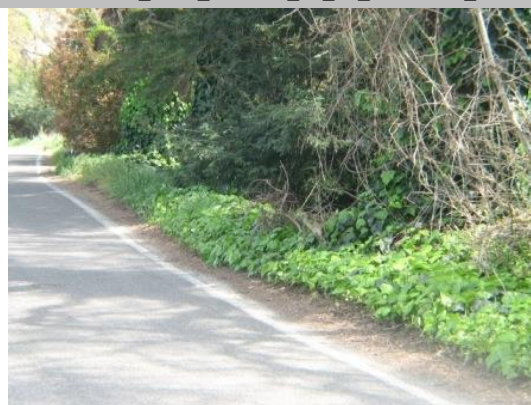
Photo 1 of 1 : SP_2019_RD0150_17_30_20190307_00011.jpg

LM Start	6.75	Rating **	U	Issue No.	30
LM End	6.81	Issue Type +	En	Location *	LS
Category	Earthen Levee			GPS Latitude/Longitude	
				Start	End
Item	Vegetation			38.395643 °	38.395953 °
				-121.537923 °	-121.536773 °
DWR ID	DWR_RD0150_03_s_2012_30				
Comment Code					
V6 : Landscaping					
Inspector Comment

Landscaping on landward slope blocking view

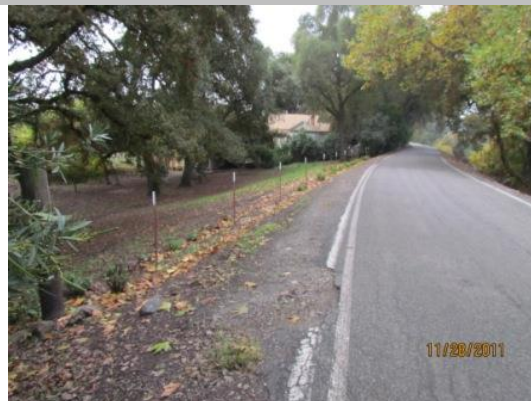
Photo 1 of 1 : SP_2019_RD0150_17_13_20190307_00004.jpg

LM Start	6.82	Rating **	M	Issue No.	13
LM End	6.93	Issue Type +	En	Location *	LS
Category	Earthen Levee			GPS Latitude/Longitude	
				Start	End
Item	Encroachments			38.395998 °	38.396982 °
				-121.536613 °	-121.535171 °
DWR ID	DWR_RD0150_03_s_2012_13				
Comment Code					
FE : Fence					
Inspector Comment

Fence was found on the landside of the levee looking downstream. Fall 2011

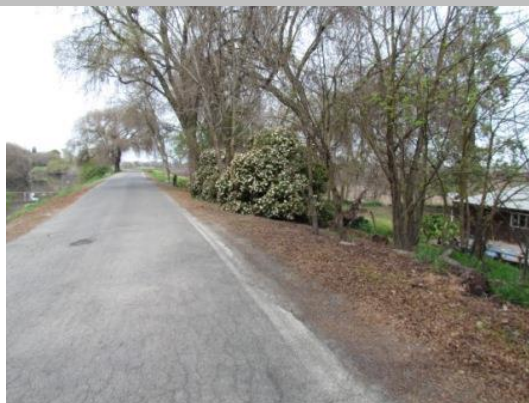
Photo 1 of 1 : SP_2019_RD0150_17_31_20190307_00012.jpg

LM Start	6.93	Rating **	M	Issue No.	31
LM End	6.97	Issue Type +	En	Location *	LS
Category	Earthen Levee			GPS Latitude/Longitude	
				Start	End
Item	Vegetation			38.397021 °	38.397540 °
				-121.535151 °	-121.535183 °
DWR ID	DWR_RD0150_03_s_2012_31				
Comment Code					
V6 : Landscaping					
Inspector Comment

Landscaping was found on the landside shoulder of the levee looking upstream.

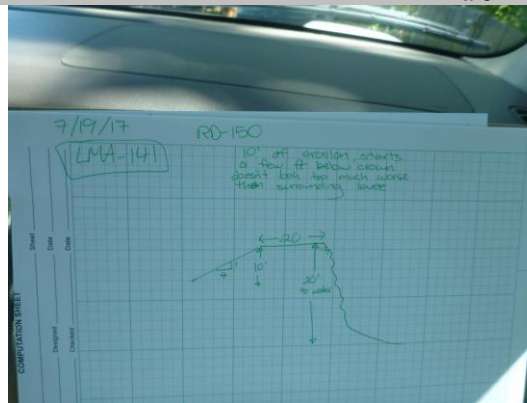
Photo 3 of 3 : LEVAL_SP_2019_314_2324.jpg

Item	2017 Storm Damage		38.397197°	38.397225°								
			-121.535089°	-121.535092°								
DWR ID	DWR_RD0150_03_f_2017_121											
Comment Code												
Inspector Comment												
<p>Levee Evaluation Comments</p> <p>Description: Erosion was observed on the waterside levee slope on the east (left) bank of Elk Slough. The site is approximately 10 feet long and progresses up to the levee crown. See attached pages for photos.</p> <p>Site ID No: 314</p> <p>Site Designation: LMA-141</p> <p>Repair Type: Erosion</p> <p>Rating: Area of Concern</p> <p>Field Date: 7/19/2017</p> <p>Notes: Area of concern because the site is so small and only looks slightly worse than the surrounding levee slope. Crown is a paved road. Spring 2019 DWR Inspection: Erosion was not visible during this inspection due to high water.</p>

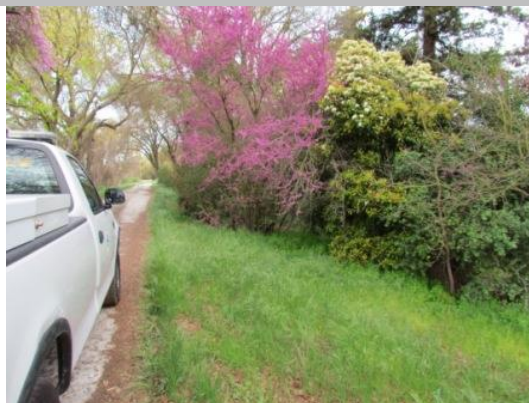
Photo 1 of 2 : SP_2019_RD0150_17_32_20190307_00013.jpg

LM Start	7.29	Rating **	U	Issue No.	32
LM End	7.34	Issue Type +	En	Location *	LS
Category	Earthen Levee			GPS Latitude/Longitude	
				Start	End
Item	Vegetation			38.401738 °	38.402296 °
				-121.537127 °	-121.537678 °
DWR ID	DWR_RD0150_03_s_2012_32				
Comment Code					
V6 : Landscaping					
Inspector Comment

Vegetation on the landside of the levee looking upstream. This picture was taken during spring 2012 inspection.

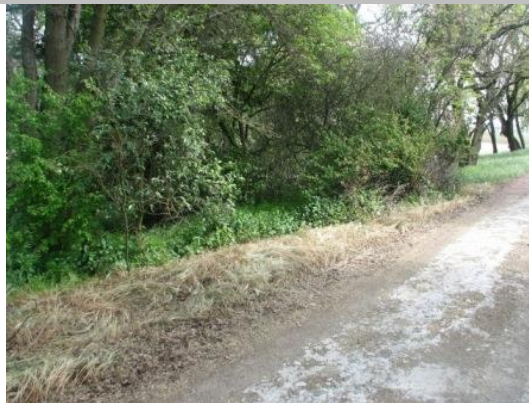
Photo 2 of 2 : SP_2019_RD0150_17_32_20190307_00014.jpg

Landscaping on landward slope blocking view

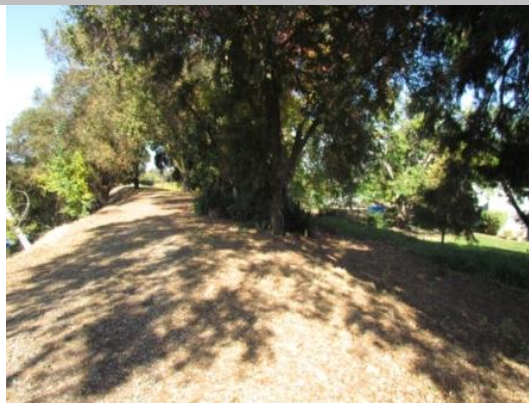
Photo 1 of 1 : SP_2019_RD0150_17_84_20190307_00069.jpg

LM Start	7.40	Rating **	M	Issue No.	84
LM End	7.40	Issue Type +	En	Location *	LS
Category	Earthen Levee			GPS Latitude/Longitude	
				Start	End
Item	Vegetation			38.403047 °	38.403047 °
				-121.538433 °	-121.538433 °
DWR ID	DWR_RD0150_03_s_2012_84				
Comment Code					
V6 : Landscaping					
Inspector Comment

Landscaping was found on the landside shoulder of the levee looking upstream.

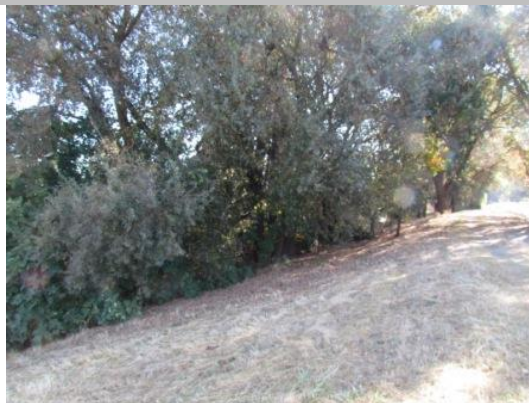
Photo 1 of 1 : SP_2019_RD0150_17_934_20190307_00120.jpg

LM Start	7.44	Rating **	U	Issue No.	934
LM End	7.44	Issue Type +	En	Location *	LS
Category	Earthen Levee			GPS Latitude/Longitude	
				Start	End
Item	Vegetation			38.403566 °	38.403566 °
				-121.538886 °	-121.538886 °
DWR ID	DWR_RD0150_03_s_2012_934				
Comment Code					
V6 : Landscaping					
Inspector Comment

Landscaping was blocking the visibility on the landside of the levee looking downstream.

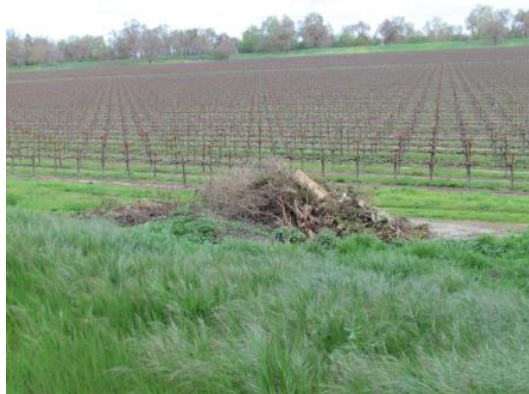
Photo 1 of 2 : SP_2019_RD0150_17_935_20190307_00121.jpg

LM Start	7.47	Rating **	M	Issue No.	935
LM End	7.47	Issue Type +	En	Location *	LS
Category	Earthen Levee			GPS Latitude/Longitude	
				Start	End
Item	Encroachments			38.403795 °	38.403795 °
				-121.539205 °	-121.539205 °
DWR ID	DWR_RD0150_03_s_2012_935				
Comment Code					
PR : Prunings					
Inspector Comment

Prunings were found on the landside of the levee looking upstream.

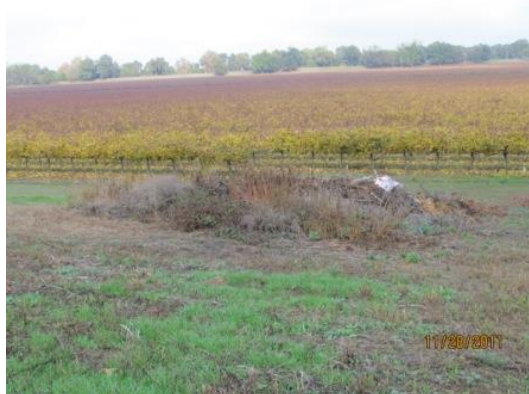
Photo 2 of 2 : SP_2019_RD0150_17_935_20190307_00122.jpg

Prunings were found on the landside of the levee looking upstream. This picture was taken during fall 2011 inspection.

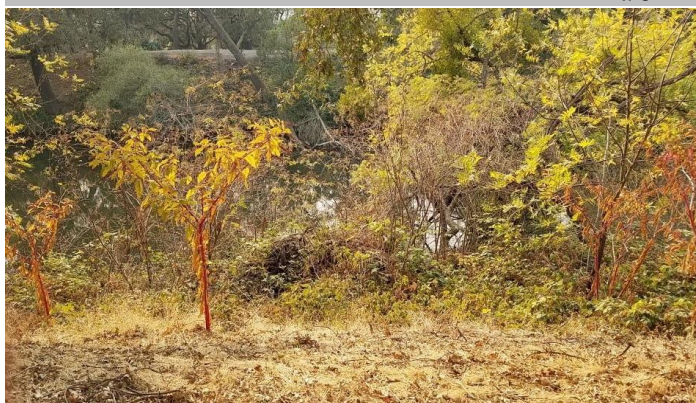
Photo 1 of 2 : SP_2019_RD0150_17_52_20190307_00037.jpg

View of the tree trunk on the waterside toe of the levee. Fall 2018

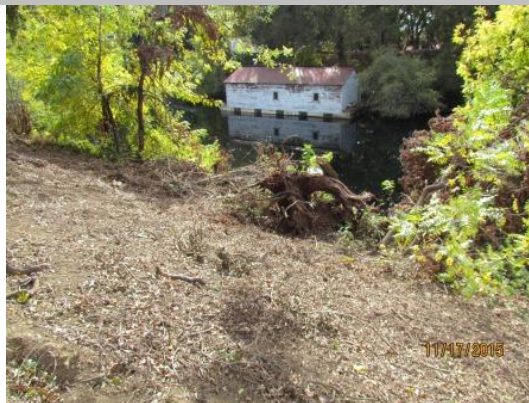
Photo 2 of 2 : SP_2019_RD0150_17_52_20190307_00038.jpg

View of the tree trunk on the waterside toe of the levee. Fall 2015

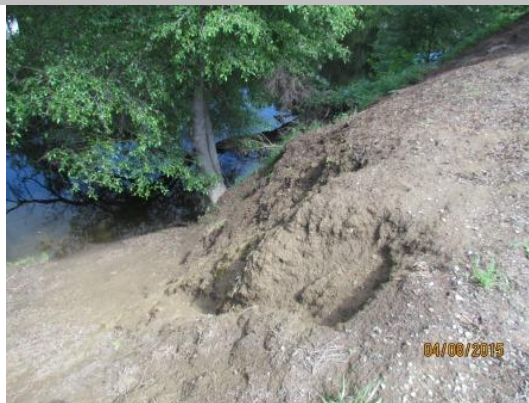
Photo 1 of 2 : SP_2019_RD0150_17_92_20190307_00077.jpg

LM Start	7.99	Rating **	M	Issue No.	92
LM End	8.02	Issue Type +	Ma	Location *	WS
Category	Earthen Levee			GPS Latitude/Longitude	
				Start	End
Item	Slope Stability			38.409010 °	38.409130 °
				-121.540513 °	-121.539971 °
DWR ID	DWR_RD0150_03_s_2014_92				
Comment Code					
S1 : Repair slope instability.					
Inspector Comment

View of slope instability on the waterside of the levee looking upstream during spring 2015 inspection.

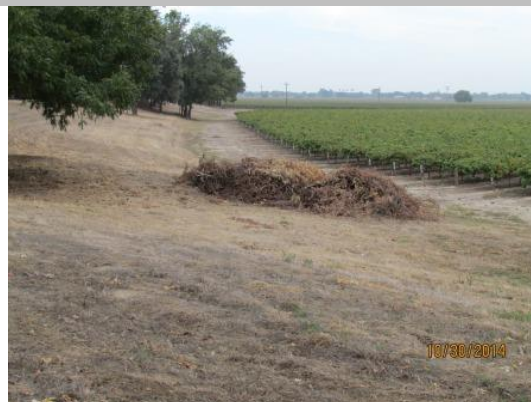
Photo 1 of 1 : SP_2019_RD0150_17_82_20190307_00067.jpg

LM Start	8.05	Rating **	M	Issue No.	82
LM End	8.05	Issue Type +	En	Location *	LS
Category	Earthen Levee			GPS Latitude/Longitude	
				Start	End
Item	Encroachments			38.409224 °	38.409224 °
				-121.539350 °	-121.539350 °
DWR ID	DWR_RD0150_03_f_2013_82				
Comment Code					
PR : Prunings					
Inspector Comment

Prunings were found on the landside toe of the levee looking upstream.
Fall 2014

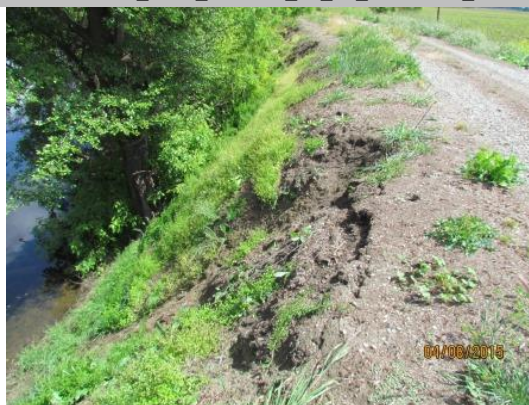
Photo 1 of 1 : SP_2019_RD0150_17_66_20190307_00054.jpg

LM Start	8.31	Rating **	M	Issue No.	66
LM End	8.31	Issue Type +	Ma	Location *	WS
Category	Earthen Levee			GPS Latitude/Longitude	
				Start	End
Item	Erosion / Bank Caving			38.407960 °	38.407960 °
				-121.534898 °	-121.534898 °
DWR ID	DWR_RD0150_03_s_2012_66				
Comment Code					
E2 : Schedule repair of erosion site prior to the next inspection.					
Inspector Comment

View of erosion on the waterside of the levee. Spring 2015

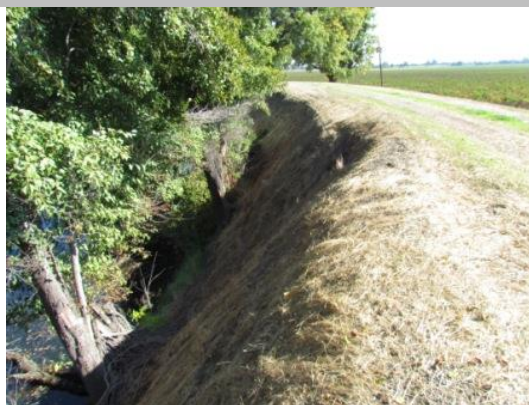
Photo 2 of 2 : SP_2019_RD0150_17_67_20190307_00056.jpg

LM Start	8.33	Rating **	M	Issue No.	67 (cont)
LM End	8.33	Issue Type +	Ma	Location *	WS

Erosion was found on the waterside shoulder of the levee looking upstream. This picture was taken during fall 2012 inspection.

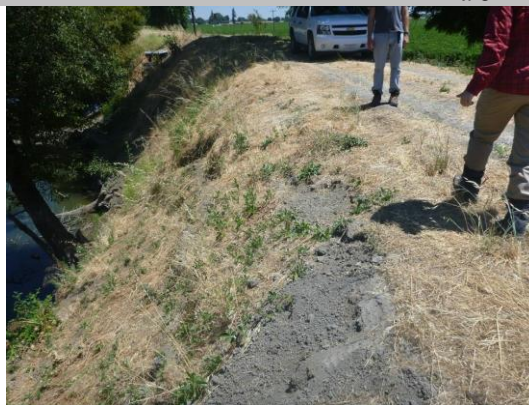
Photo 2 of 3 : LEVAL_SP_2019_316_2181.jpg

LM Start	8.35	Rating **	A/W	Issue No.	123 (cont)
LM End	8.35	Issue Type +	Ma	Location *	WS

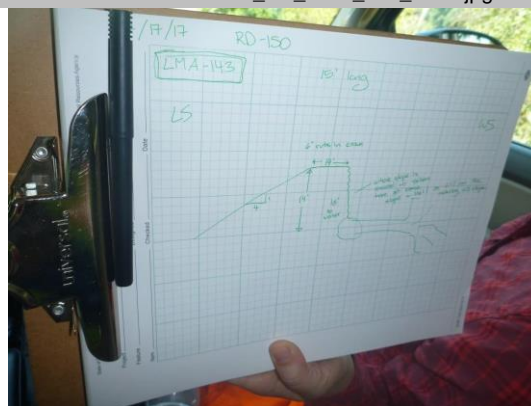
Photo 3 of 3 : LEVAL_SP_2019_316_2182.jpg

LM Start	8.35	Rating **	A/W	Issue No.	123 (cont)
LM End	8.35	Issue Type +	Ma	Location *	WS
Category	Supplemental		GPS Latitude/Longitude		
			Start	End	
Item	2017 Storm Damage		38.407983 °	38.407992 °	
			-121.534322 °	-121.534289 °	
DWR ID	DWR_RD0150_03_f_2017_123				
Comment Code					
Inspector Comment					
<p>Levee Evaluation Comments</p> <p>Description: Erosion was observed on the waterside levee slope on the east (left) bank of Elk Slough. The site is approximately 10 feet long. See attached pages for photos.</p> <p>Site ID No:316</p> <p>Site Designation:LMA-143</p> <p>Repair Type: Erosion</p> <p>Rating: Serious</p> <p>Field Date:7/17/2017</p> <p>Notes: 3 large trees in/adjacent to site including a fallen tree in the middle of the erosion. Erosion on almost the whole slope, but doesn't cut into the crown. Serious because erosion cuts into levee significantly here.</p>

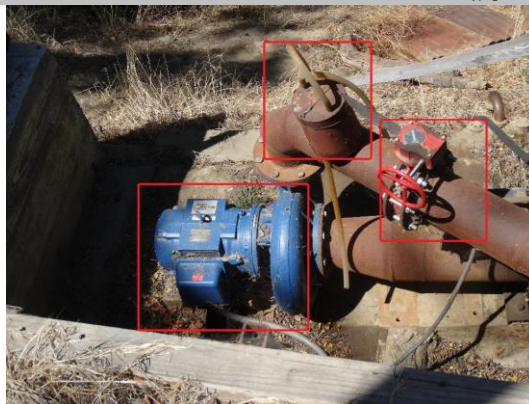
Photo 2 of 3 : UCIP_SP_2019_41648_33641.jpg

WS view: pump, gate valve, and airvent on pipe inside concrete masonry box.

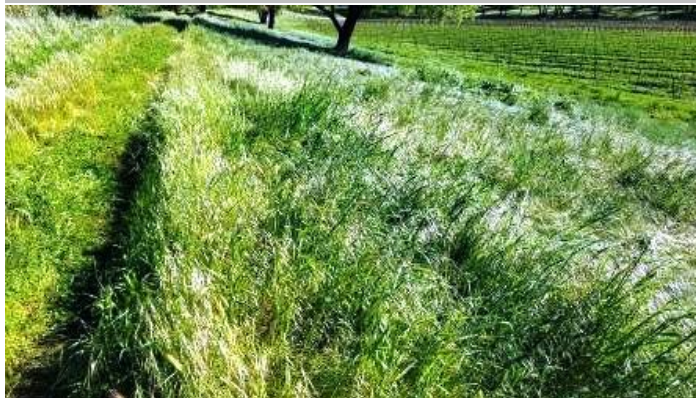
Photo 1 of 1 : SP_2019_RD0150_17_41_20190415_00168.jpg

LM Start	8.41	Rating **	M	Issue No.	41
LM End	9.11	Issue Type +	Ma	Location *	LS
Category	Earthen Levee			GPS Latitude/Longitude	
				Start	End
Item	Vegetation			38.408595 °	38.414322 °
				-121.533490 °	-121.527080 °
DWR ID	DWR_RD0150_03_s_2019_41				
Comment Code					
V1 : Control annual grass and weeds on the levee slopes and easements.					
Inspector Comment

View of tall landside vegetation. Spring 2019

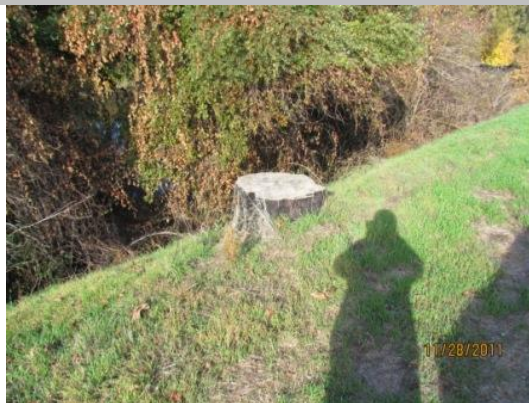
Photo 1 of 1 : SP_2019_RD0150_17_55_20190307_00042.jpg

LM Start	8.50	Rating **	N	Issue No.	55
LM End	8.50	Issue Type +	Ma	Location *	WS
Category	Earthen Levee			GPS Latitude/Longitude	
				Start	End
Item	Trim / Thin Trees			38.409559 °	38.409559 °
				-121.532356 °	-121.532356 °
DWR ID	DWR_RD0150_03_s_2012_55				
Comment Code					
T5 : Tree stumps.					
Inspector Comment

A tree stump was found on the waterside of the levee looking upstream.
Fall 2011

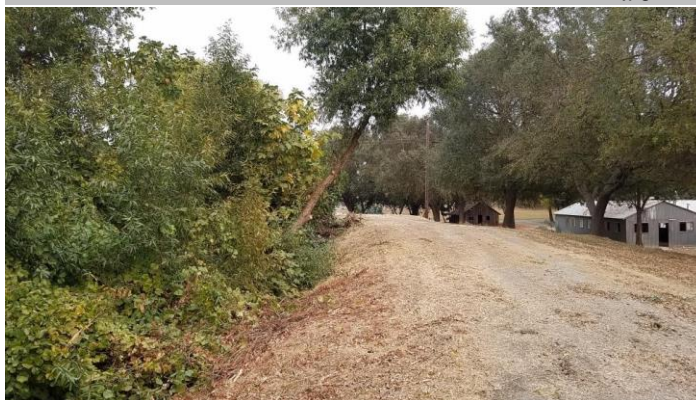
Photo 1 of 3 : SP_2019_RD0150_17_73_20190307_00059.jpg

LM Start	9.31	Rating **	U	Issue No.	73 (cont)
LM End	9.35	Issue Type +	Ma	Location *	WS

View of dense vegetation within levee easement. Fall 2018

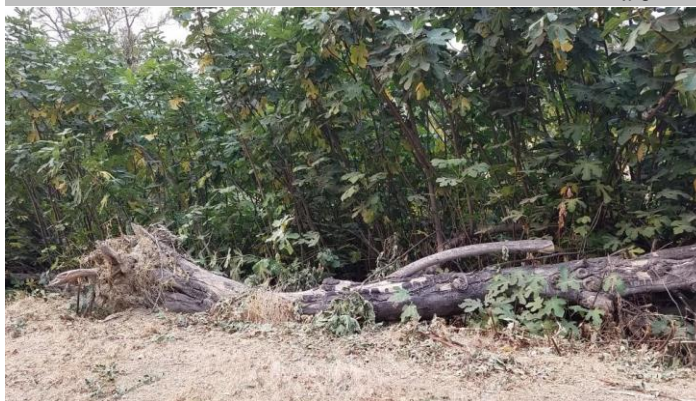
Photo 2 of 3 : SP_2019_RD0150_17_73_20190307_00060.jpg

View of fallen tree on levee slope. Fall 2018

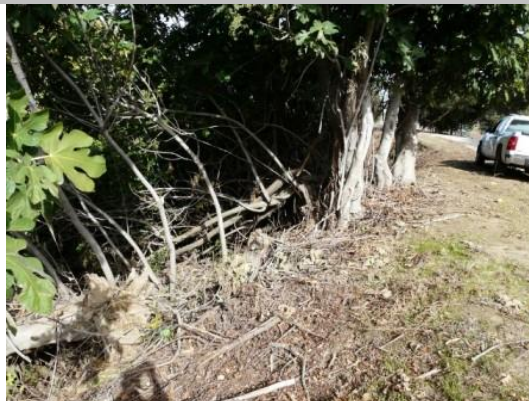
Photo 3 of 3 : SP_2019_RD0150_17_73_20190307_00061.jpg

LM Start	9.31	Rating **	U	Issue No.	73 (cont)
LM End	9.35	Issue Type +	Ma	Location *	WS

Thin/trim trees to allow for visibility of top 20' of waterward slope.

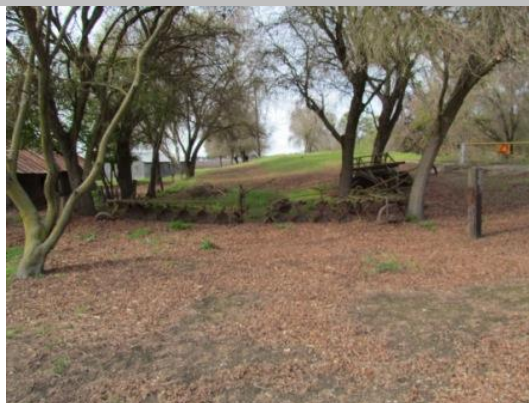
Photo 1 of 1 : SP_2019_RD0150_17_950_20190307_00124.jpg

LM Start	9.39	Rating **	M	Issue No.	950
LM End	9.39	Issue Type +	En	Location *	LS
Category	Earthen Levee		GPS Latitude/Longitude		
			Start	End	
Item	Encroachments		38.413560 °	38.413560 °	
			-121.522936 °	-121.522936 °	
DWR ID	DWR_RD0150_03_s_2012_950				
Comment Code					
EQ : Equipment					
Inspector Comment

Equipment was found on the landside of the levee looking downstream.
